Shire of Dowerin RFQ 2024-02 Leak Detection Evaluation

Dowerin Swimming Pool

SHIRE OF DOWERIN LEAK DETECTION REPORT

4th May 2021

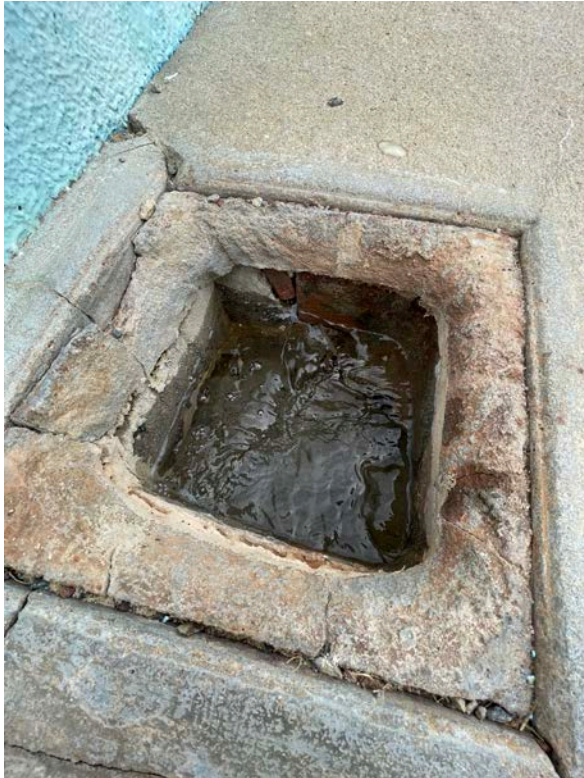
There have been leaks detected in the gravity pipework that runs from the pool and back to the balance tank.

The gravity pipework is too small for the plant room flow rate, which is causing the pipes to fill and leak through cracks and pool sealing in the concourse.

Bricks were also noted to be in place where repair jobs may have been attempted in the past.

Brickwork below waterline of gravity pipework

We recommend the gravity pipework be upgraded to allow the plant room flow.

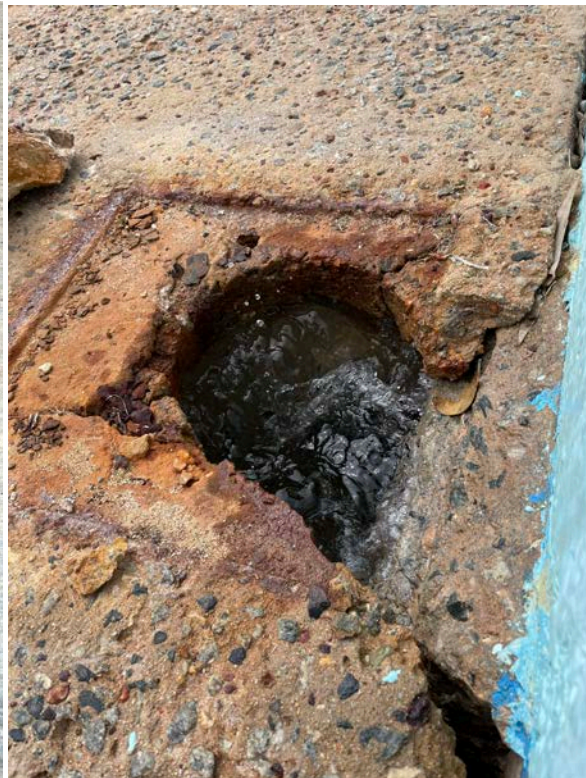
Drummy areas in the concourse behind the pool indicated undermining of the soil below as a result of the leaks found

Cracks in inspection pits behind pool end wall
